Strawberry Run Stream Restoration

Ft. Williams Park

North of Duke Street between Donelson St.
and Ft. Williams Parkway

Transportation and Environmental Services, Office of Environmental
Quality

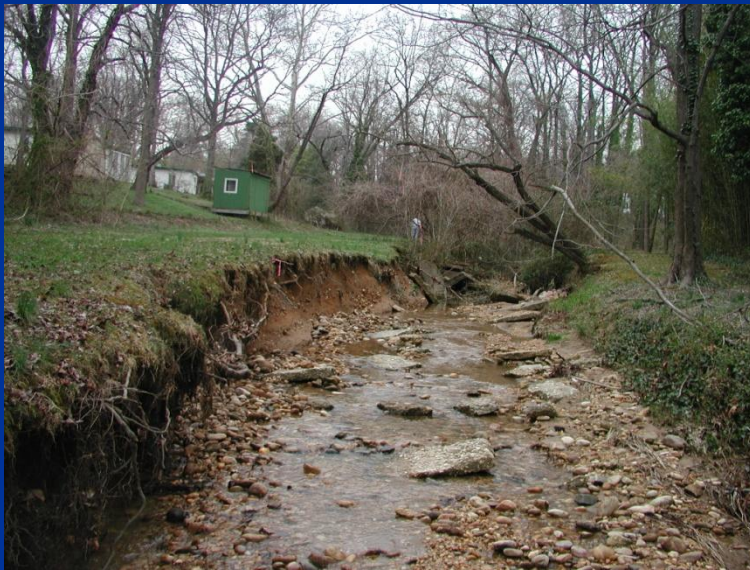
2005

Strawberry Run suffers from high velocities as evidenced by the down-cutting creating the vertical side banks and depressed stream bed. There is also a considerable amount of concrete and other debris in the stream that serves to negatively deflect flows creating erosive forces.

Looking upstream toward the bridge

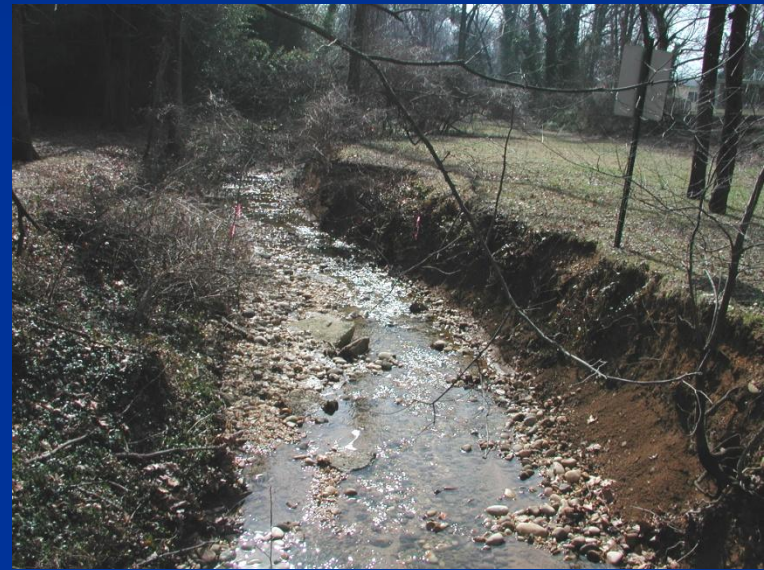
2004

Looking downstream from the bridge

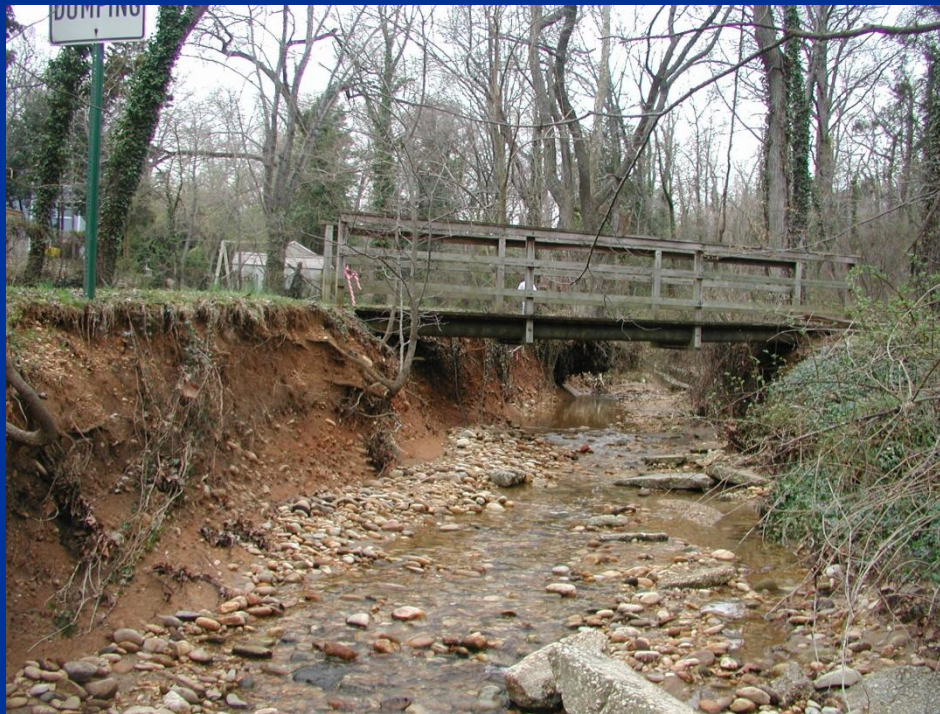
The bridge worked to pinch off the stream. The banks eroded and the stability of the bridge was threatened. While it doesn't look spectacular in this picture, it was decided that this bridge could be a signature piece in the restoration.

Looking upstream toward bridge (2005)

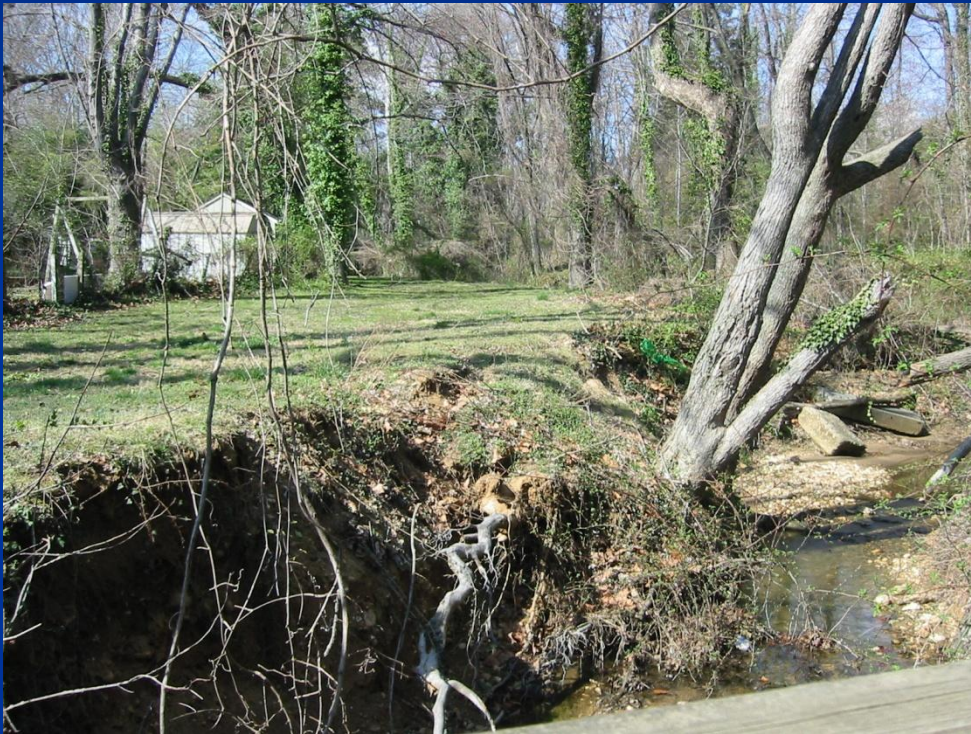
On the right in this picture you see a tree where the dirt under the root system has been eroded away (undercut). Eventually the tree falls into the stream because there is no subsurface to hold it upright.

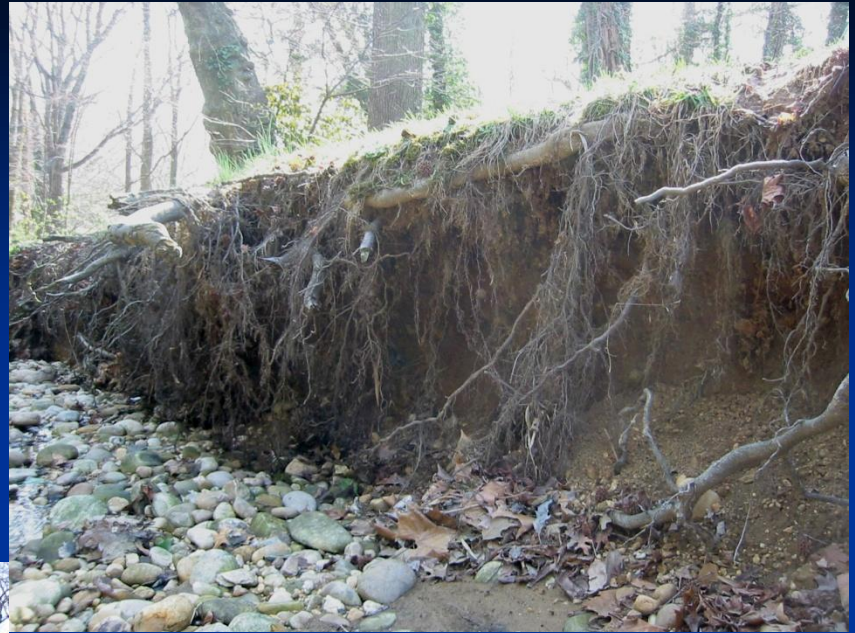
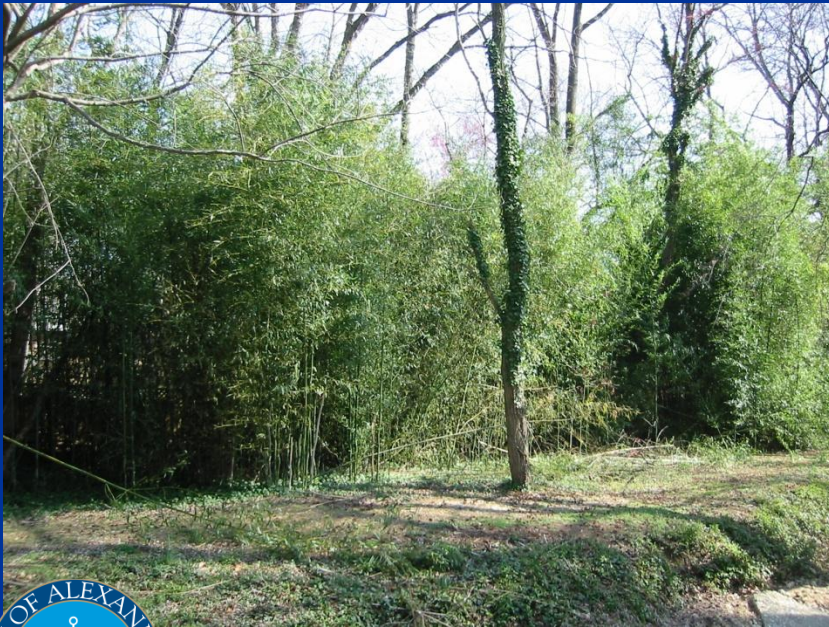
This is another example of the erosive forces of water undercutting the vegetation that usually anchors the stream bank in place. What is left is dangling roots.

Here you see some examples of invasive species that need to be removed. Note the Bamboo and English Ivy climbing the trees. Ivy will eventually kill this tree and the bamboo competes with other native plants (trees and bushes) that would otherwise provide habitat for riparian animals and birds.

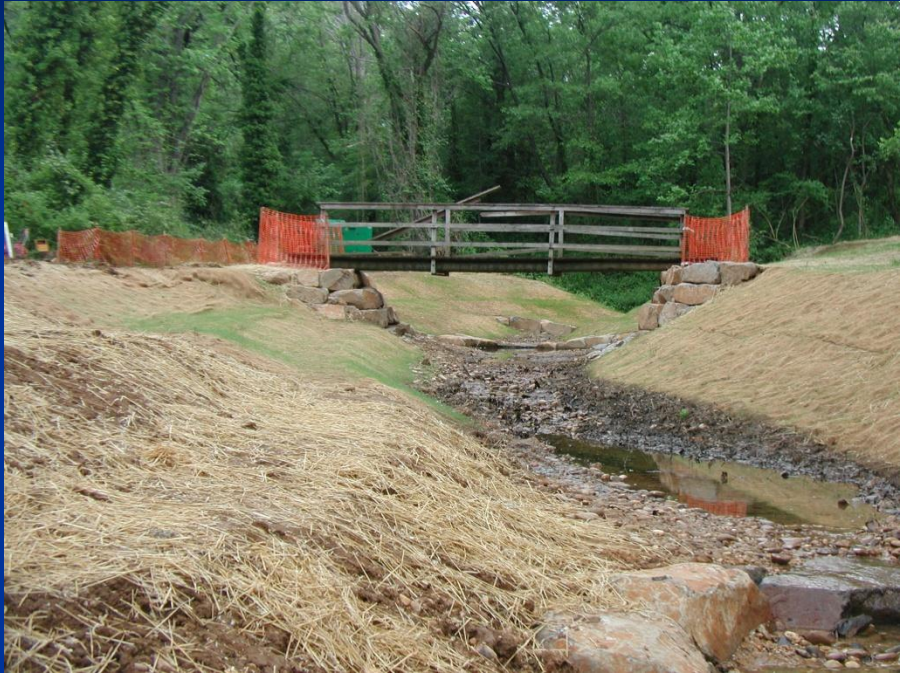
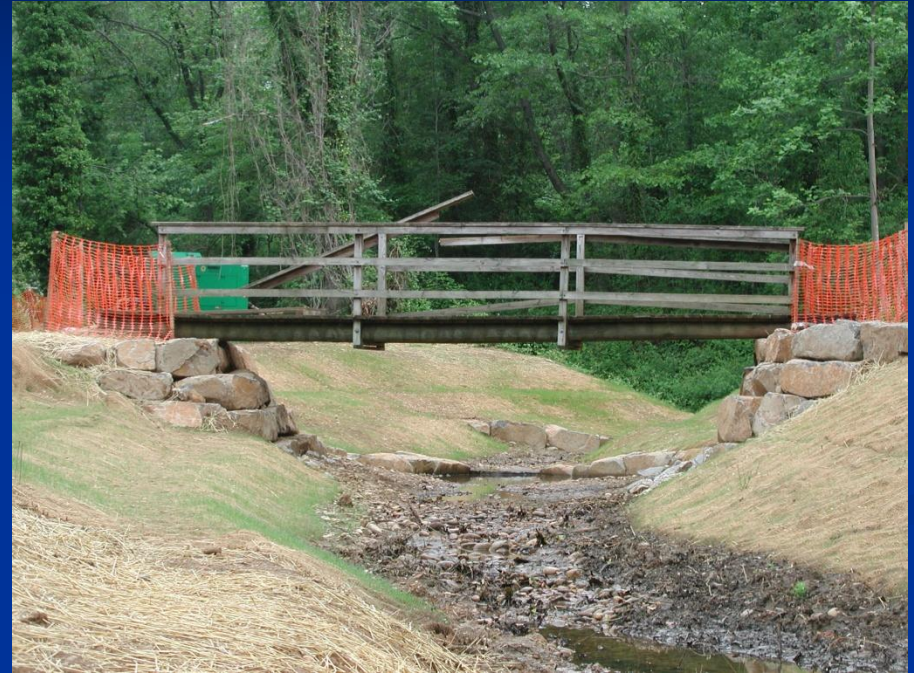
Bridge just needs a few repairs. You try lifting a bridge in one piece and not breaking anything.
